APPLICATION OF FLAW DETECTION METHODS FOR DETECTION OF FATIGUE PROCESSES IN LOW-ALLOYED STEEL

Zbigniew Hilary ŻUREK

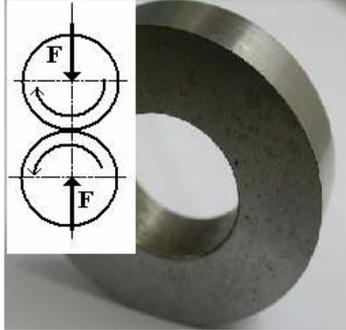
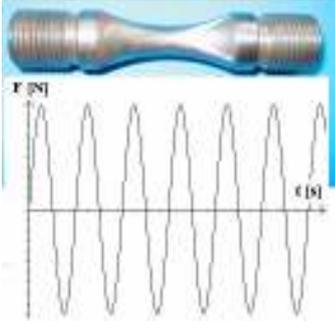
Table 1: Types of samples

P54T steel used in railway engineering for the rim of wheel -set rims has been used in tests [2, 3]. The following types of samples have been prepared: hourglass-type – for scalable application of cyclic fatigue load (at MTS universal testing machine), and ring-type – for contact loads at AMSLER stand (Table 1). The preparation of the samples is shown in Table 2. The material microstructure compared with the cyclic mechanical loading data is documented in Table 3. The comparison of the material microstructure due to different load histories is shown in Table 4.

for contact loads at AMSLER stand	for cyclic fatigue load at MTS stand

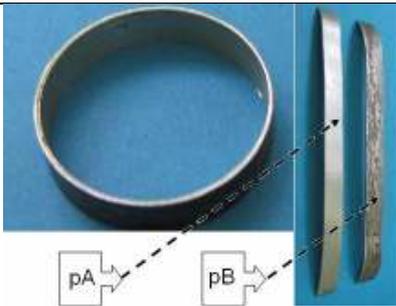
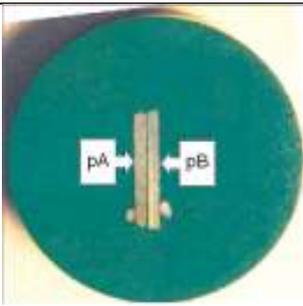
Table 2: Sample preparation process

Ring samples – sample preparation process

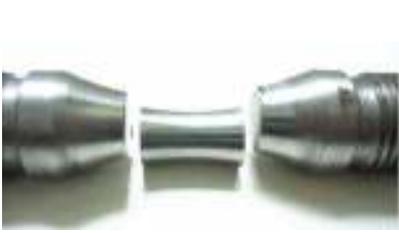
Hourglass-type samples - sample preparation process

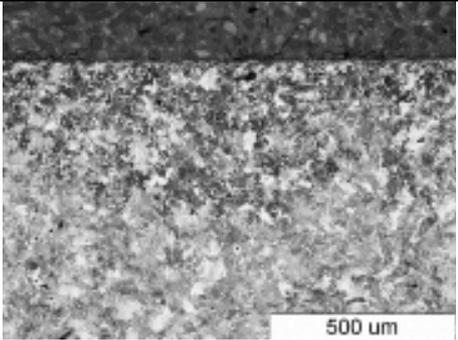
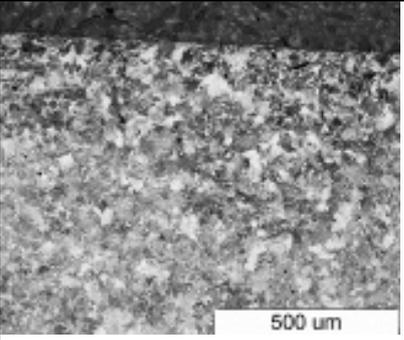
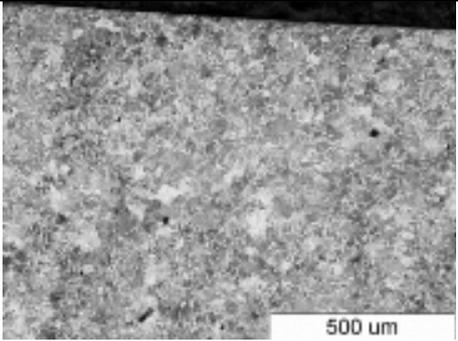
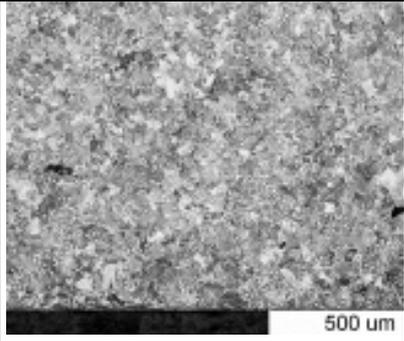
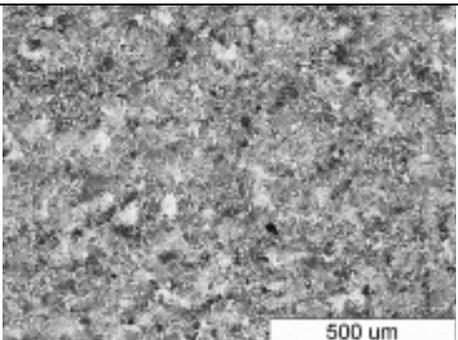
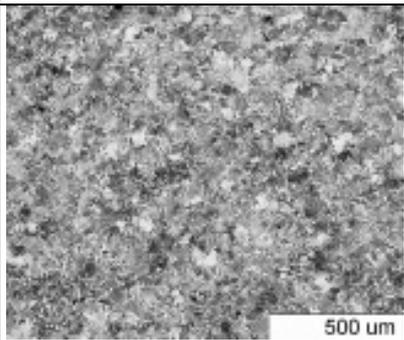
Table 3: Material microstructure vs. cyclic mechanical load cycles

No. of cycles	Hourglass-type samples material structure	
120 000 cycles 78% fatigue life

80 000 cycles 52% fatigue life

60 000 cycles 39% fatigue life

Effects due to fatigue are seen in the final stage of fatigue process. For hourglass-type samples the changes are located irregularly along the percentage reduction of area, in the middle (the narrowest part). The thickness of dark layers observed in the photos does not exceed several-hundredths to several-tenths of millimetre. Samples prepared for microscopic examination (hourglass and ring types both) have been next tested by magnetic methods by the BEMI.

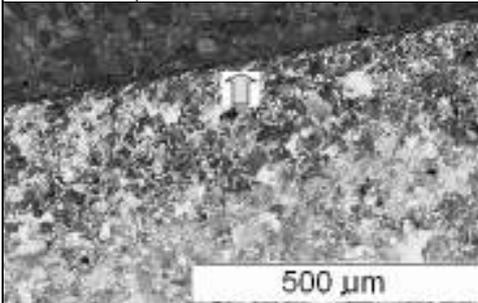
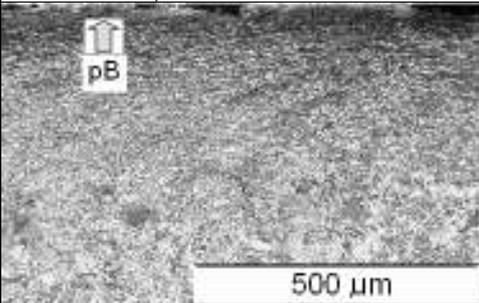
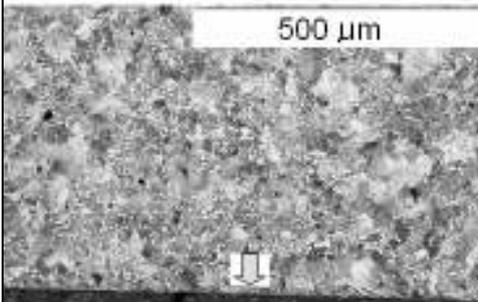
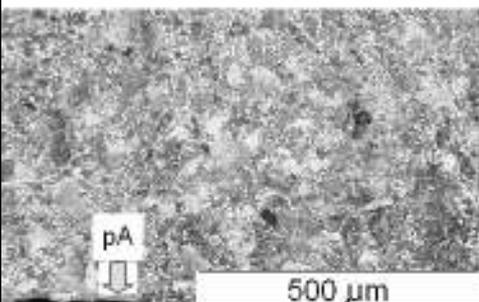
Table 4.: Comparison of material microstructure degradation, material subjected to cyclic and contact mechanical loads

Contact loads Ring sample / AMSLER stand	Cyclic loads Hour-glass sample / MTS machine

<p>500 μm</p> <p>Material surface after loading</p>

<p>500 μm</p> <p>Material surface before loading</p>

<p>500 μm</p> <p>Material surface before loading</p>
100% sample surface fatigue (flaking)	78% sample surface fatigue

The change of material microstructure in the ring sample is due to contact load. The improper loading leads to laminations and flaking at bigger depths than those shown in the photos. Additionally phase changes take place and this also determines the fatigue process. Deformation of the grains as well as displacements occur and this is one of the basic causes of fatigue cracks emergence.

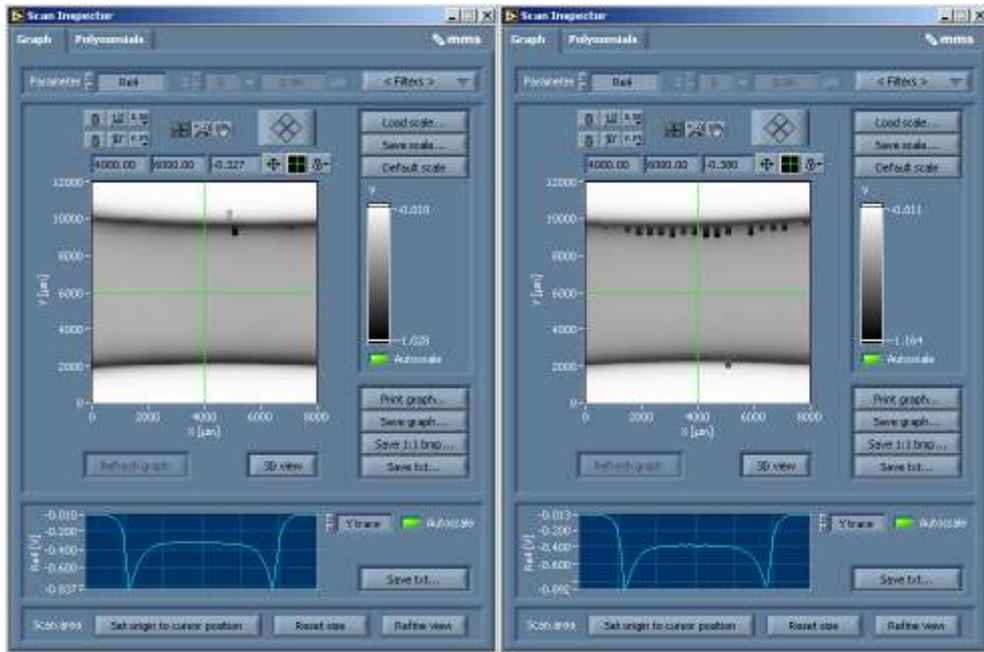
Figure 1: Graphical user interface windows for (2 MHz) eddy-current - test results for samples with 80000 cycles (left), and 120000 loading cycles (right)

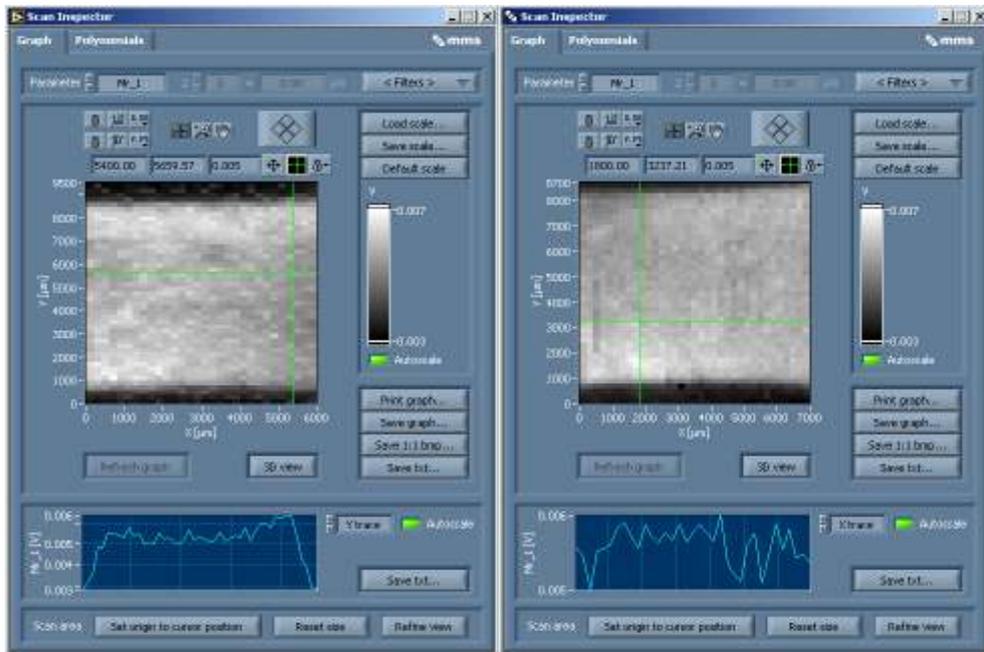
Figure 2: Graphical user interface windows for the Barkhausen noise analysis – test results for samples with 80000 cycles (left), and 120000 loading cycles (right)

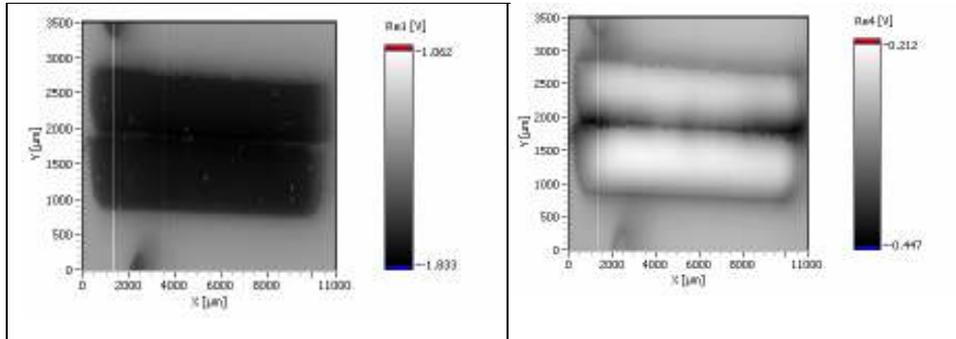
Figure 3 shows results of eddy-current scanning of surfaces pA and pB samples for 0,5MHz and 2 MHz.

Figure 3: Graphical user interface window information for eddy-current analysis.

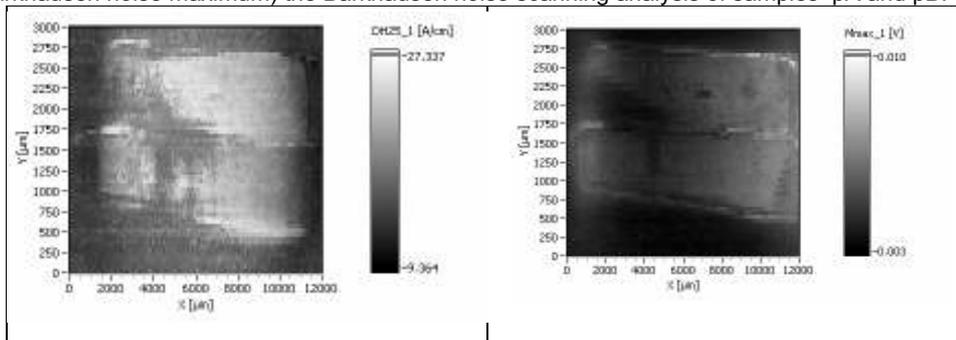
Figure 4 shows results of (DH25 = full peak width at 25% of the maximum and M max = Barkhausen noise maximum) the Barkhausen noise scanning analysis of samples pA and pB.

Figure 4: Graphical user interface window information for the Barkhausen noise scanning analysis

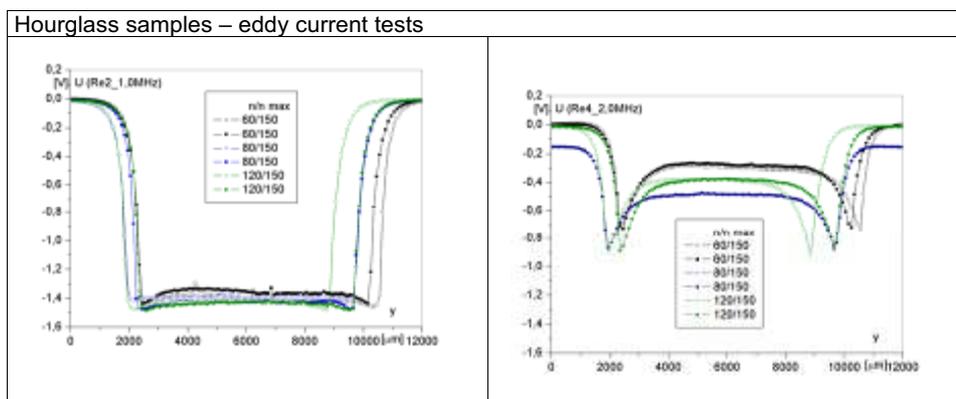
The detection of the fatigue processes at the hourglass sample surfaces was effectively possible for eddy current frequencies greater than 2 MHz, as shown in Figure 5. The number of cycles investigated ranged from a set number n to maximum number n_{max} as a function of probe signal.

Figure 5: Comparison of eddy current testing
Such a detection was not possible by comparing amplitudes of probe signals during Barkhausen noise testing (Figure 6).

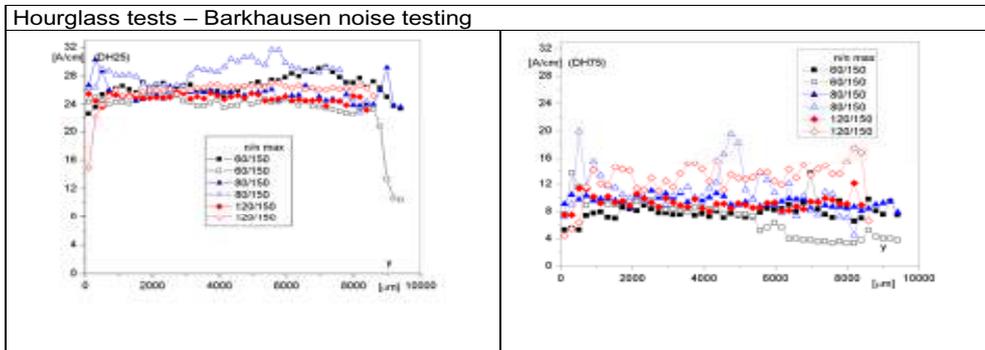
Figure 6: Comparison of Barkhausen noise testing

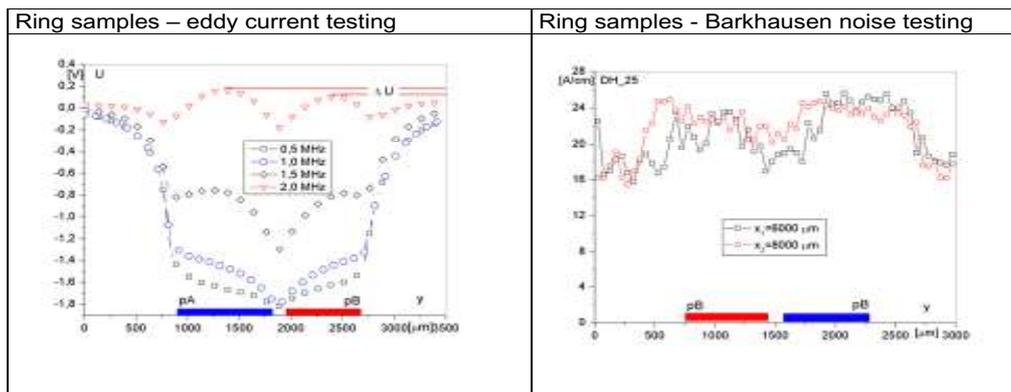
As opposed to these facts, in case of contact-loaded ring samples a separation between pA and pB samples was possible by eddy current tests for frequencies greater than 2 MHz. However, Barkhausen noise method, made the characterization of the contact-loaded sample possible, as shown in Figure 7.

Figure 7: Comparison of Barkhausen noise and eddy current testing

The results prove that only contact-loaded samples may be tested by both eddy currents and Barkhausen noise methods.

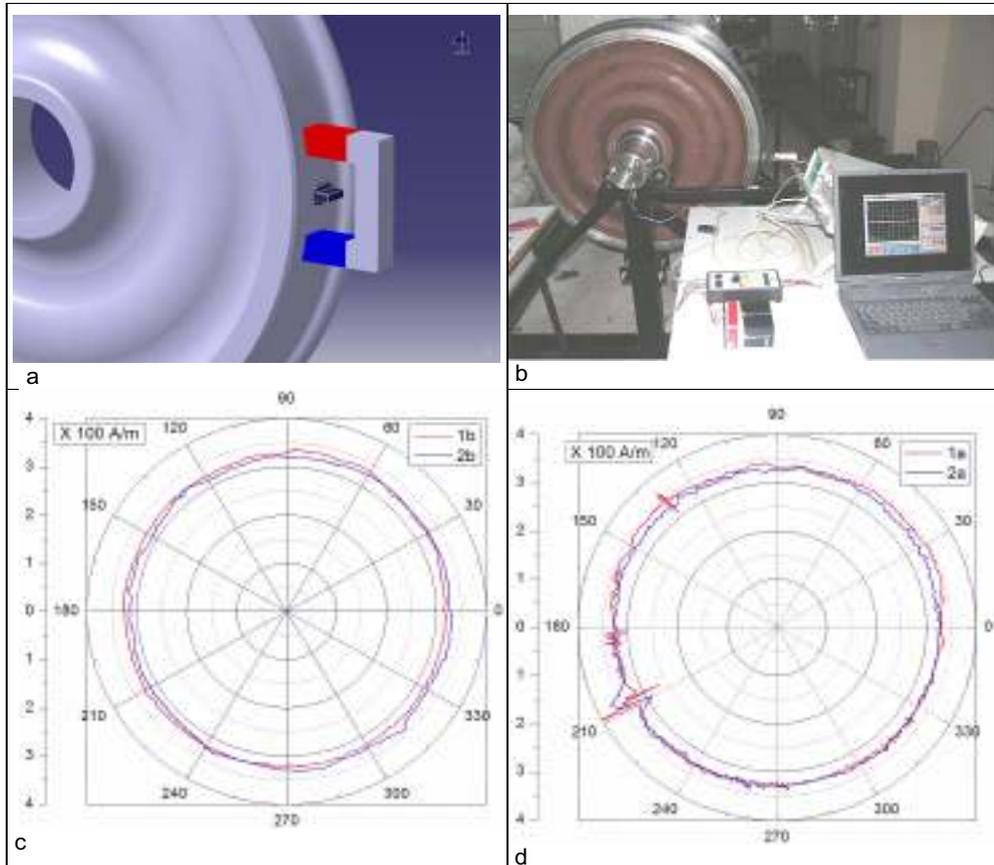
Figure 8: Measurement principle – a, testing – b, leakage magnetic field in a brand-new wheel – c, leakage magnetic field in a damaged wheel – d.

The amplitudes of the eddy-current impedance measurement do not reflect the material's condition at 0,5 and 1 MHz frequencies. For frequencies greater than 2,0 MHz eddy-current signals show some differences in the material condition for contact-loaded samples pA and pB. In case of Barkhausen noise method the differentiation between material changes was possible for contact-loaded samples only. The change in material's magnetic parameters (up to 30 per cent) due to fatigue stresses was detected by the eddy current method – the signal increased at approximately the same rate (up to 30 per cent) for both magnetic permeability and coercivity. When the Barkhausen noise method was applied, the results were not so obvious. It must be noted that for the BEMI microscopic inspection the samples were specially prepared. In real life and when the railway wheel set rolling surface is investigated, the detection may be highly effective if leakage magnetic field is measured [4] (Figure 8).

The eddy currents with 2 MHz or higher frequencies only penetrate element's surface near zones. More significant information for subsurface layers may be obtained by analyzing the magnetic leakage field, and in particular, by investigating the tangential component of this field. The BEMI microscope principle is useful in fundamental research; however, in practice (in railway transport service diagnostics) testing of tangential component of leakage magnetic field is a very effective research method, whereas the information on changes in the material's continuity obtained from eddy current or ultrasonic tests is supplementary.
