17th World Conference on Nondestructive Testing, 25-28 Oct 2008, Shanghai, China  
**ULTRASONIC ECHO-PULSE TOMOGRAPHY OF CONCRETE USING  
SHEAR WAVES LOW-FREQUENCY PHASED ANTENNA ARRAYS**

**Alexandr V. BISHKO<sup>1</sup>, Andrey A. SAMOKRUTOV<sup>2</sup>, Victor G. SHEVALDYKIN<sup>2</sup>**

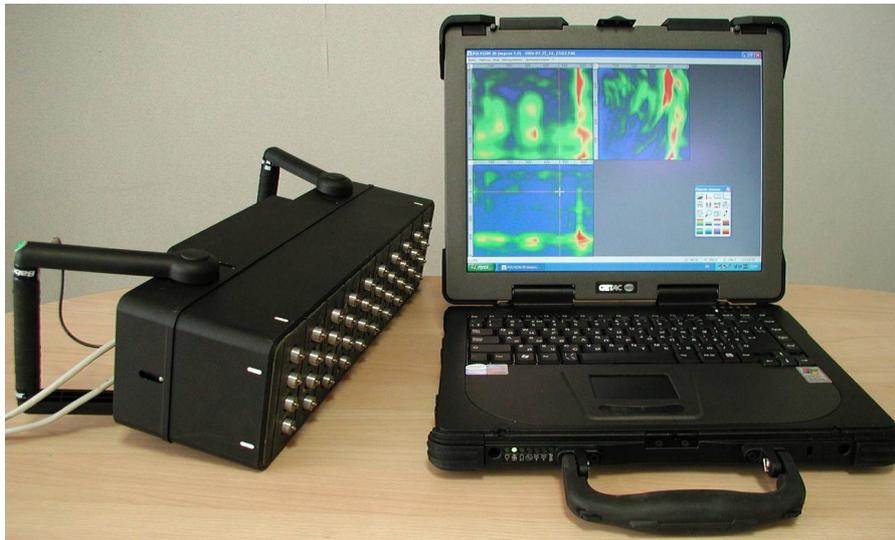
**Fig. 1. Low-frequency ultrasonic tomograph for concrete testing A1040M MIRA (MIRA).**

The Tomograph utilizes a patented phased matrix array of 40 shear wave transducers, organized in 10 units by 4 elements each and controlling unit of Laptop type for data accumulation and processing. The Dry-Point Contact elements with individual spring loading to the testing surface are used as elements of the antenna array. The frequency spectrum of signals is from 30 to 120 kHz with the central operation frequency of 50 kHz. Sending and reception of signals is made in combinations between the units. The space-time processing is based on SAFT-C method [1, 2]. The photo of the Tomograph is represented on the fig. 1.

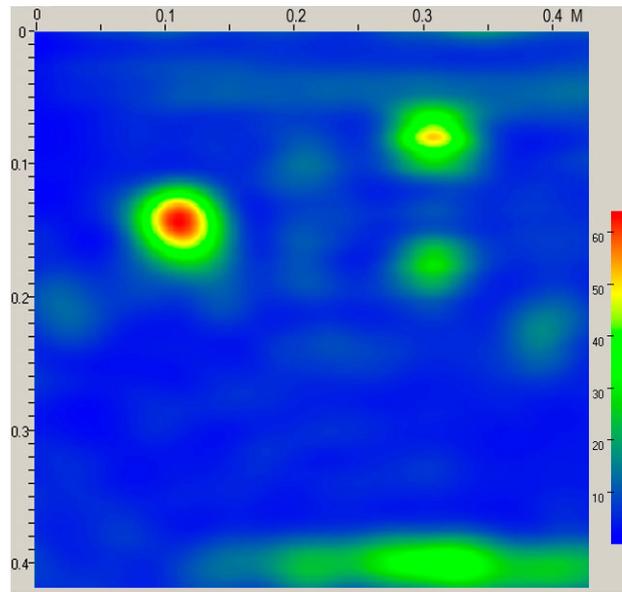
**Fig. 2 The cross section image (B-scan) received with the Tomograph A1040M MIRA on the concrete block 400 mm thick.**

Fig. 2 shows the example of B-scan image (tomogram), received with the Tomograph A1040M MIRA on the concrete block 400 mm thick with three drillings, running parallel to the testing surface. The visualized image is perpendicular to the drillings, imitating the long inclusions or defects inside the concrete structure. The large image corresponds to the larger drilling 30 mm in diameter on the depth of 140 mm from the surface; the two drillings are 13 mm in diameters on depths 80 and 180 mm depths (images on the right). In the bottom is the backwall image.

The given example shows high sensitivity and resolution of the Tomograph. The sizes of the artificial reflectors – drillings are smaller than the wavelength and not more than 50 mm.

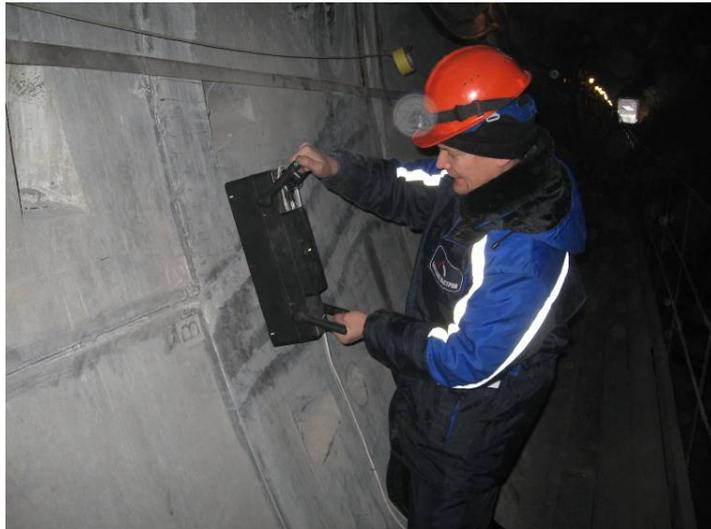
**Fig.3 Application of the Tomograph A1040M MIRA for quality assessment of abuilding railway tunnel near Krasnoyarsk.**

The Tomograph A1040M MIRA was used for quality estimation of concrete paneling in abuilding railway tunnel (see fig.3).

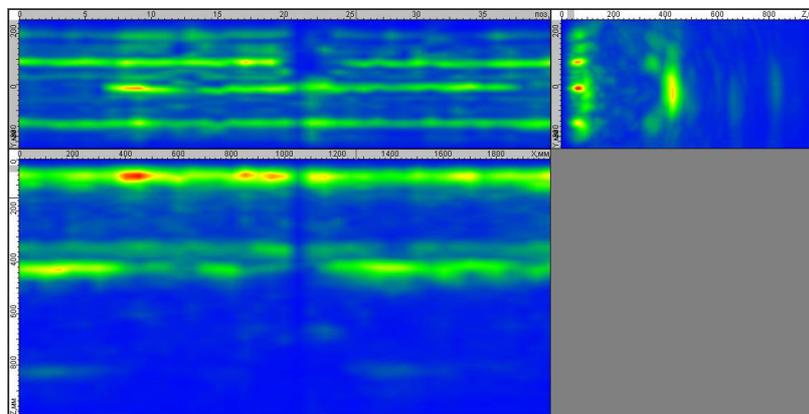
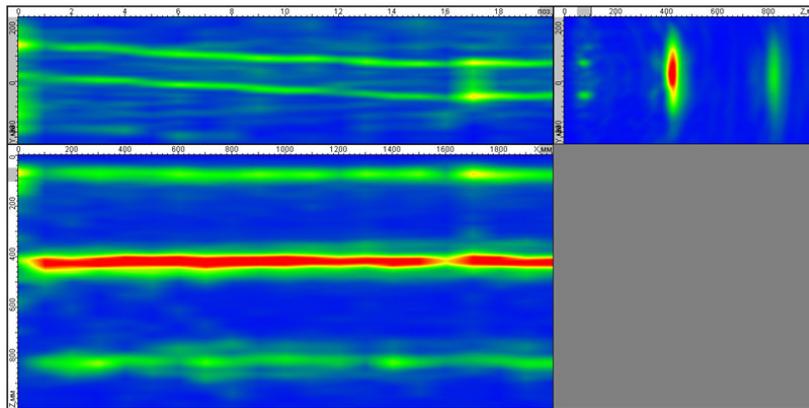
**Fig. 4. Images received with the Tomograph A1040M MIRA on the paneling: a) in case of well-grouted area and b) non-grouted area. The thickness of paneling is 400 mm, the shear waves ultrasound velocity is 2800 m/sec.**

Fig. 4 represents the results as B-, C- and D-scans for both cases: non-grouted area behind the paneling and well-grouted area behind the paneling.

The given examples shows the applicability of the Tomograph both for thickness measurements on concrete objects and for imaging the internal structure, visualizing the positioning of reinforcement bars on different depths inside the panels. Both images are given in the same way as they are represented on the display of the Tomograph.

The upper image is the C-scan - the view from the top - of the tested area. On the C-scan image the positioning of reinforcements bars is clearly seen, the diameter of the reinforcement bars according to the specification of the panels is 20 mm.

To the right is the B-scan image in one (chosen by the operator) position of the antenna array. According to the scale on the top can be concluded that the top layer of reinforcement bars is on the depth of 70 mm from the surface, the backwall signal corresponding to the thickness of the panels is at 400 mm and above the backwall signal the light image of bottom layer of reinforcement bars can be detected. The image of the bottom reinforcement layer does not coincide with the upper reinforcement layer, which is confirmed by the construction drawings of the panels and allows concluding that the images close to the bottom are the image of the reinforcement bars and not the second reflection from the top reinforcement layer.

The lower section on the fig.4 is the D-scan – the section view from the side, the left scale at that shows the depth and the upper scales – united for C- and D-scans gives the coordinates along the scanning line. Both D-scans on the fig. 4 shows the top reinforcement bars layer and the backwall signal.

In case of bad grouting or absence of grouting mixture behind the paneling the intensity of the backwall signal is very high (shown with the red color on the image), at that the second backwall reflection is clearly seen. In case of good grouting behind the paneling the intensity of the backwall signals reduces significantly (the level of the backwall signal is not higher then the level of signals from the reinforcement bars). The second backwall appears only in two places, which can be the air holes behind the paneling.

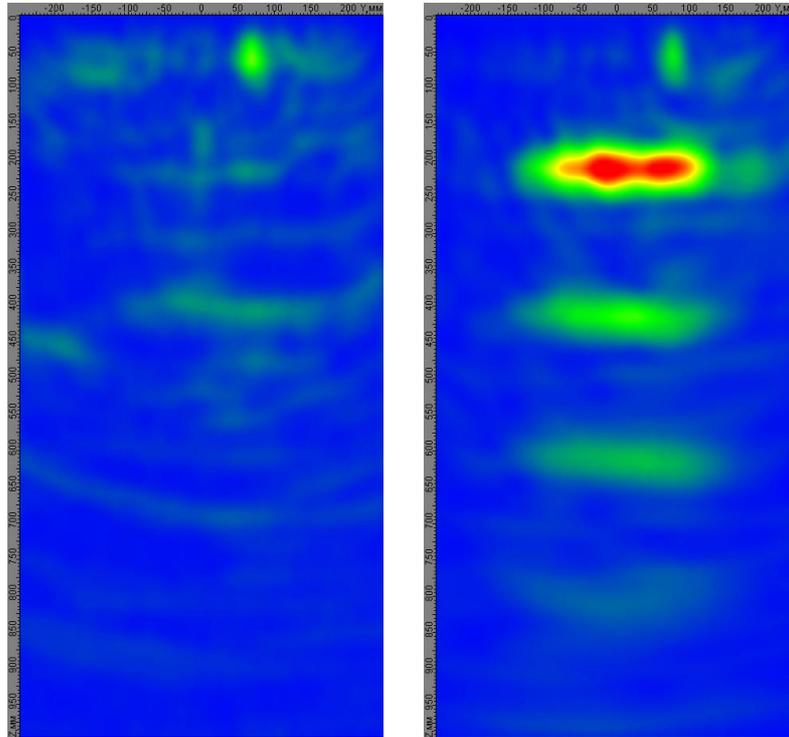
**Fig. 5 Images received at testing the underground tunnel of Moscow Metro: left – with grouting behind the paneling and right – with air behind the paneling.**

The similar testing task was solved with the Tomograph A1040M MIRA in the underground tunnel of Moscow Metro, though in this case it was easier, due to the impedance difference of the paneling material and grouting mixture. There was no backwall signal in the areas of grouting behind the panels. The example images received on the paneling of Moscow Metro underground tunnel are given on the fig. 5. There are two B-scans represented: one with the air behind the paneling, another one with the grouting mixture.

In case of air behind the paneling (fig. 5 right) there is a backwall signal of high intensity at the depth of 200 mm, as well as multiple backwall reflections at 400, 600 and 800 mm, herewith confirming that the panel contacts with the air or soft medium and the whole ultrasound energy is reflected from the bottom of the panel and not penetrating further.

In case of presence of grouting mixture behind the paneling (fig. 5 left) the backwall signal on the depth of 200 mm is of very low intensity, almost absent, the similar reflection appears at 400 mm. This allows concluding that the backside of the paneling is in good contact with the grouting mixture filling up to 400 mm depth then changed with the soil. There are no multiple reflections, confirming that the main ultrasound energy is penetrating to the soil due to the good contact between the paneling, grouting mixture and soil.

There are bright spots on the depth between 50 and 100 mm on both images on fig 5, which is the reinforcement, crossing the section in these positions of the antenna array.

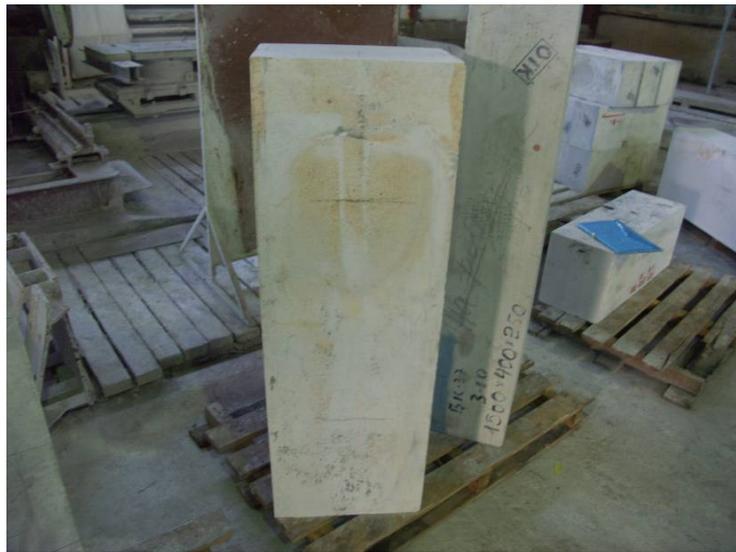
**Fig. 6 Refractory blocks from “BAKOR” material.**

Fig. 6 and fig 7 represents the refractory blocks and testing results correspondingly. The image (fig. 7) shows the example, received on the block with a defected integrity area at the depth of 100 mm from testing surface, which lays in the area 700-1125 mm from the zero scanning point. The area has a square form and resembles a kind of delamination.

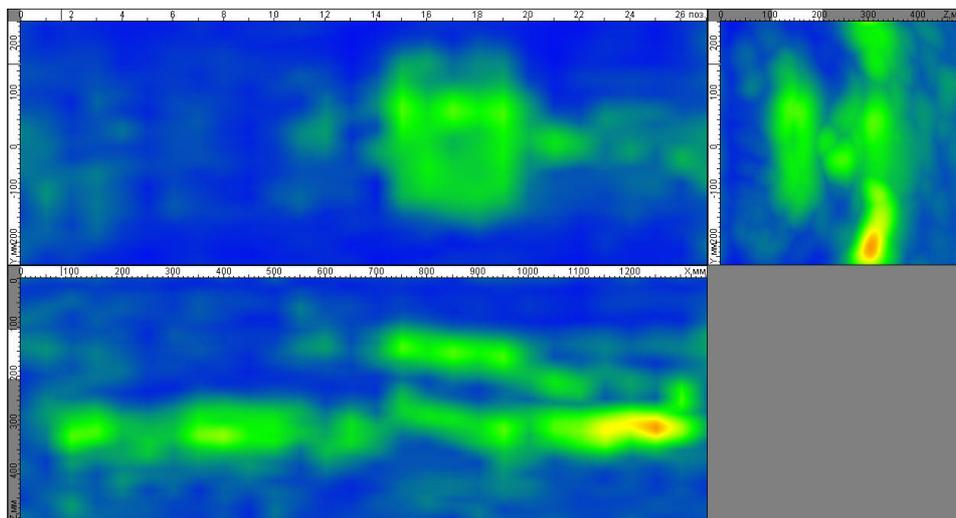
**Fig. 7 Images received at testing the refractory block BK-37 from BAKOR material, the shear wave ultrasound velocity in the material 4073 m/sec.**
